CBP Needs to Improve Its Video and Audio Coverage at Land Ports of Entry

OFFICE OF INSPECTOR GENERAL

Department of Homeland Security

September 25, 2023

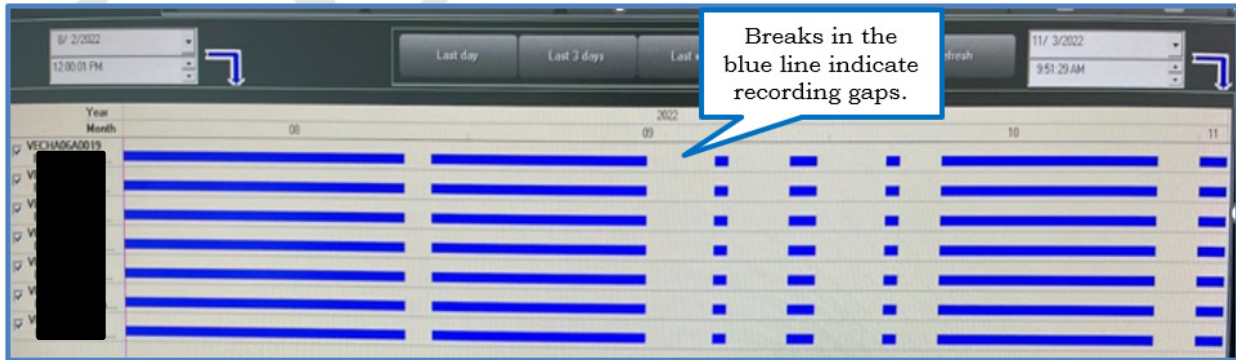
Figure 1. Video Recording Software Illustrating Intermittent Recording Gaps from August 2 through November 3, 2022

We observed CAVSS video recording gaps at all 10 LPOEs we visited, with some gaps ranging from multiple days to a few months. While onsite, we confirmed the video could not be played back during the time of these recording gaps. At one LPOE, we observed seven cameras only recording intermittently for 15 days over 3 months, as shown in Figure 1. In this instance, personnel assigned to the LPOE could not tell us why the cameras were not recording video. Additionally, LPOE personnel reported this recording issue to the BSDP PMO help desk contractors responsible for maintaining and troubleshooting issues with CAVSS; the contractors did not provide the cause but confirmed no video recordings were available.

Recording gaps were a widespread issue primarily caused by equipment not always rebooting after the Office of Information and Technology applied required network patches and conducted required scans.¹⁸ Additionally, BSDP PMO did not assess the impact of the patches and scans on live video feeds and recording capabilities. Finally, outdated equipment makes it harder to apply patches and conduct scans because the current video management system has surpassed its life cycle.

CBP Response to Recommendation 1: Concur. BSDP PMO will coordinate with the Office of Information and Technology's Cyber Security Directorate to seek a less invasive scanning and patching approach, to include identifying tools available to minimize impacts to scanning and patching and develop a plan to mitigate any identified impacts. Additionally, BSDP PMO is researching other video management solutions with a visualization dashboard of system performance that alert video surveillance system operators when equipment is offline. Estimated Completion Date: January 31, 2024.

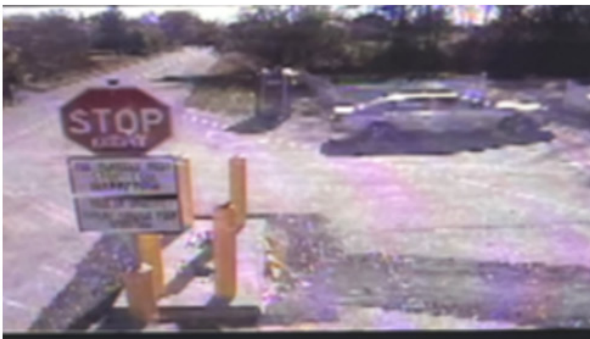
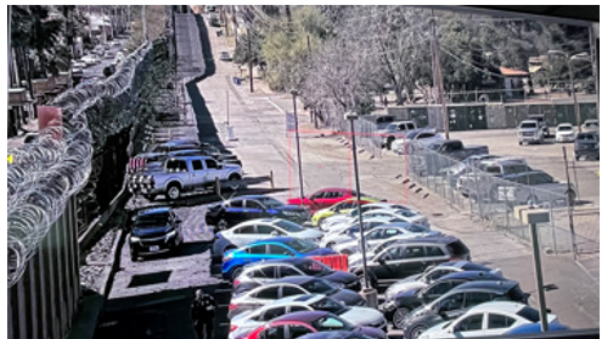
Figure 3. Comparison of the Image Quality for an Older Analog Camera vs. a Newer Digital Camera at Two LPOEs

We observed 101 instances of poor image quality for CAVSS footage at 18 LPOEs. Overall, the IP cameras produced much clearer images than analog cameras, as shown in Figure 3.

As of May 2023, LPOEs had approximately 12,274 video surveillance cameras of which 57 percent (7,007) were analog cameras and 43 percent (5,267) were IP cameras. ISC and CBP physical security standards note that analog cameras should be replaced with IP cameras when possible. Further, BSDP PMO considers analog cameras to be outdated technology and officials said they will replace all analog cameras with IP cameras as funding and network infrastructure are available. Network infrastructure that supports CAVSS equipment is inadequate at some LPOEs, contributing to poor image quality.

CBP Response to Recommendation 2: Concur. BSDP PMO will review all LPOEs to identify video surveillance equipment requiring upgrades and will work with the Office of Information and Technology to identify network infrastructure gaps and recommendations for alternative solutions when network infrastructure is not available or cannot be upgraded. BSDP PMO will also develop a risk management plan outlining the need for a new video surveillance solution to meet operational needs at the LPOEs, including factors such as operating environment and limitations. Estimated Completion Date: January 31, 2024.

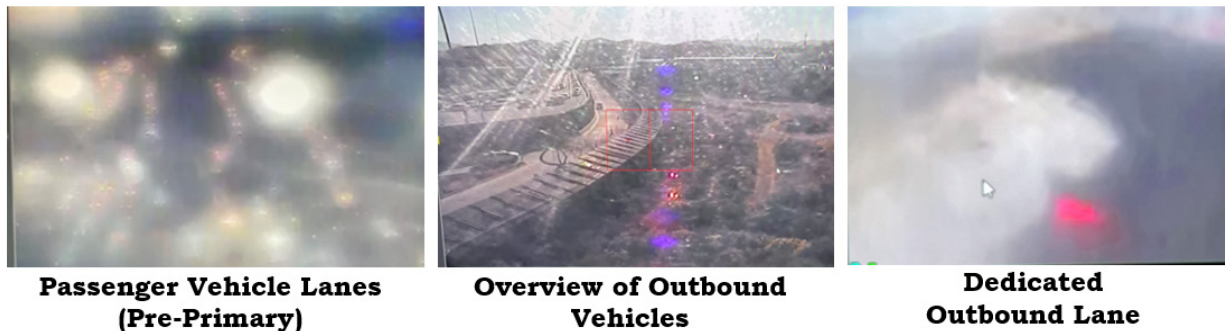
Figure 5. Examples of Poor Image Quality for IP Cameras at Two LPOEs

We also observed some instances of poor image quality from IP cameras resulting from needed maintenance, including the cleaning of camera lenses. Figure 5 shows examples of poor image quality for an area where passenger

vehicles line up to approach the LPOE primary inspection area, as well as areas that vehicles travel to exit the United States.

Although BSDP PMO currently requires preventative maintenance at each LPOE twice per year, we observed some cameras that had not received such maintenance. In some cases of cameras with poor image quality, a help desk ticket had been submitted for the camera to be cleaned or replaced. BSDP PMO officials said they had explored providing additional preventative maintenance but found it to be cost prohibitive. As an alternative, BSDP PMO pursued a health dashboard for more proactive monitoring, but due to the age of the existing video management system, determined it would be too costly.

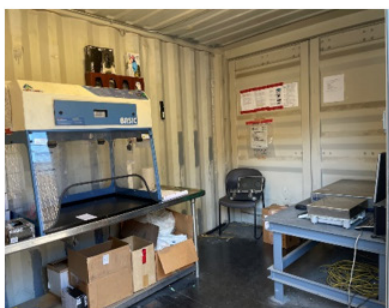
Seizure Processing Area

Figure 7 shows three LPOE areas without required video coverage where seized drugs are processed and weighed, seized property and contraband are temporarily stored, and weapons are stored.

Figure 7. Three Examples of LPOE Areas With No Video Coverage

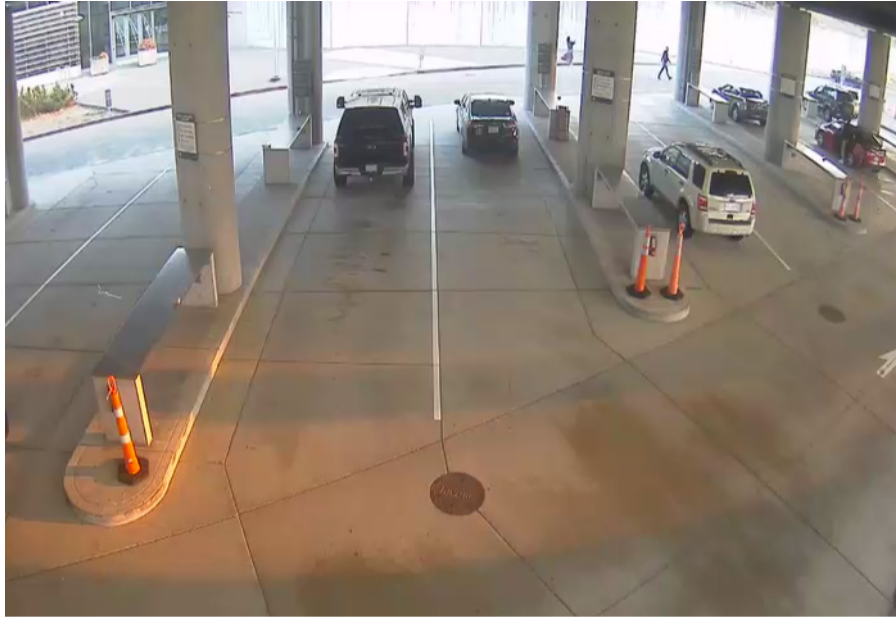
Figure 8. Example of an Image from Cameras Covering Secondary Vehicle Inspections at One LPOE

BSDP PMO requires all CAVSS equipment to comply with the approved device list and be accessible for viewing at the CASC. We observed an LPOE with approximately 18 video cameras that were not on the approved device list and did not feed into the CASC. This occurred because the Office of Facilities and Asset Management did not coordinate with BSDP PMO before purchasing and installing the equipment at the LPOE. According to LPOE personnel, these cameras were intended to address gaps in video coverage for the secondary vehicle inspection process (see Figure 8) and capture outbound operations and were purchased and installed for about \$140,000.

Personnel at one LPOE justified the use of video equipment not connected to CAVSS by referring to the limitations of OFO's current video management system and equipment. Specifically, personnel stated that the current system and equipment have a very limited field of view, often produce poor image quality, and have limited capabilities to accurately capture images of vehicles and plates in outbound lanes at all LPOEs within their field office. According to LPOE personnel, when encountering port runners or confused motorists, they were often unable to obtain details needed to identify the vehicle, such as license plate or even the make/model.

Recommendation 5: We recommend the CBP Office of Information and Technology Assistant Commissioner implement a process to ensure video and audio surveillance equipment installed complies with applicable security and privacy controls required by DHS network standards, CBP information security policies, and Centralized Area Video Surveillance System Design Standards for design and operation, as applicable.

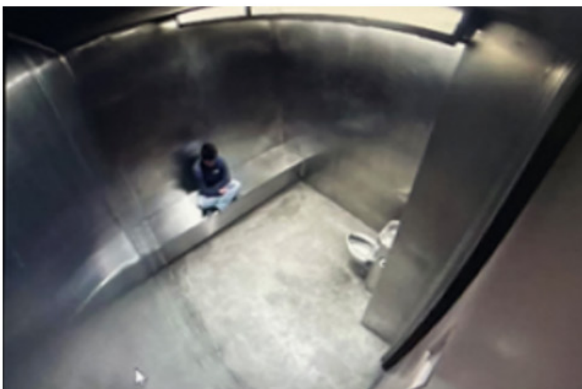
No Privacy Panel or Video Masking

LPOEs did not always have the required protection for the detainee’s privacy when using the toilet. At two LPOEs, we observed four hold rooms with toilets that did not have any privacy protections — in these instances, there was no blurred video or physical structure (privacy panel). We also identified two hold rooms at one LPOE with physical structures that did not provide sufficient privacy. Figure 12 shows examples of these hold rooms with toilets.

Figure 12. Examples of Inadequate Privacy Protections for Hold Rooms with Toilets at Two LPOEs

Recommendation 6: We recommend CBP's Border Security Deployment Program Project Management Office, in collaboration with CBP's OFO Directors of Field Operations, take immediate action to ensure all land ports of entry have the required privacy protections for hold rooms with lavatory facilities.

CBP Response to Recommendation 6: Concur. BSDP PMO will task the OFO field offices with ensuring that LPOEs have the required privacy protections in place in the video management system. If they are not in place, field offices will be required to provide the camera names to BSDP PMO for action. Estimated Completion Date: November 30, 2023.
