CBP Needs to Improve Its Video and Audio Coverage at Land Ports of Entry

OFFICE OF INSPECTOR GENERAL

Department of Homeland Security

September 25, 2023

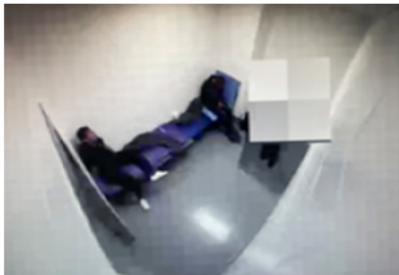
Video Masking

Figure 11. Examples of Adequate Privacy Protections for Detainees in Hold Rooms with Toilets at Three LPOEs
