**CBP's Management of
International Mail
Facilities Puts Officer
Safety and Mission
Requirements at Risk**

CBP's Management of International Mail Facilities Puts Officer Safety and Mission Requirements at Risk

August 31, 2023

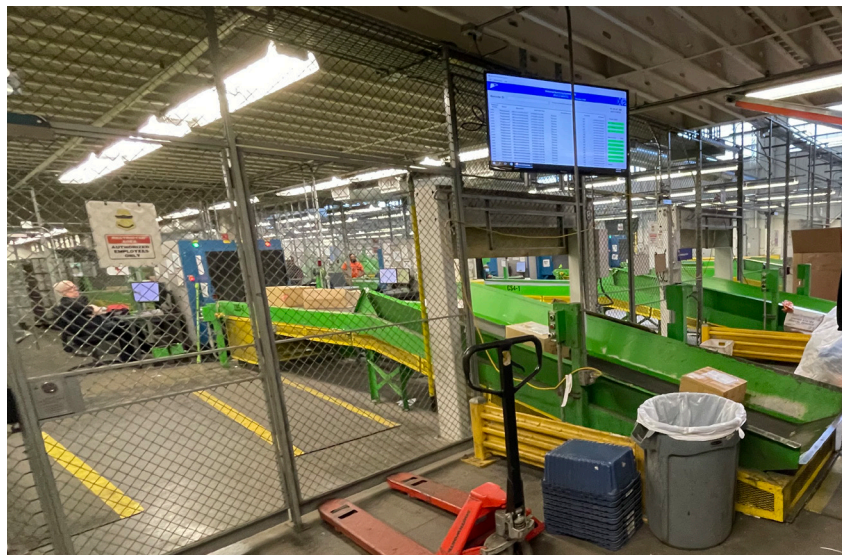
Figure 1. Conveyor Belt USPS Uses to Route Mail for CBP Screening at Chicago IMF

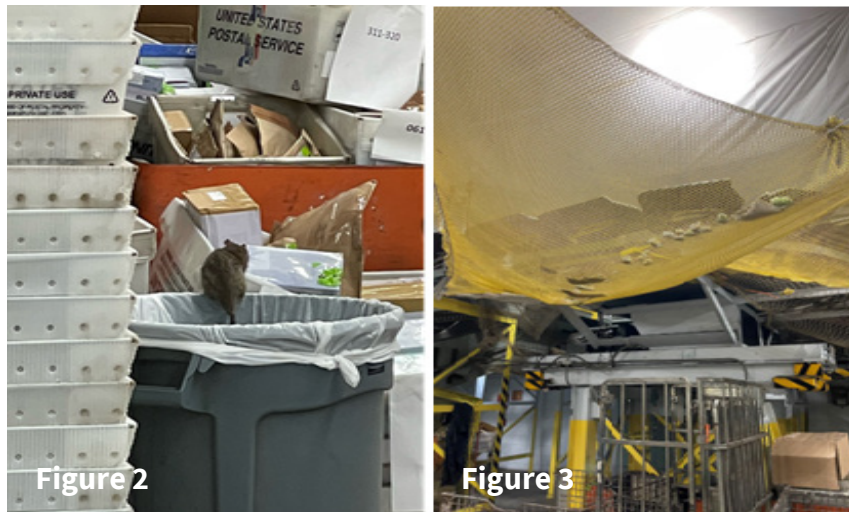
In addition to the deficiencies documented in the facility assessments, IMF and GSA officials identified other maintenance issues as early as 2018. At the Chicago IMF, CBP and GSA officials documented and requested resolution for trash blocking CBP's radiation inspection area that prevented access for emergency vehicles, repeat rodent infestations (see Figure 2), and a sink hole in the parking lot that impacted a nearby mobile lab. According to a Chicago IMF official, CBP reported the maintenance issues to USPS and GSA repeatedly. Additionally, at the Newark IMF we observed an area covered with a safety net that had filled with debris (see Figure 3). Newark mission support staff said that there are industry standards for safety features but were unaware if the net met these standards.

Figures 2 and 3. Chicago IMF Rodent Infestation (left) and Newark IMF Safety Net with Debris (right)

These issues occurred because OFAM did not prioritize monitoring and resolving facility deficiencies and other maintenance issues at the IMFs. According to an OFAM official, OFAM's senior leadership was aware that IMFs had difficulty resolving deficiencies locally and, therefore, conducted the facility assessments in anticipation of meeting with GSA and USPS senior leadership to resolve the deficiencies. However, OFAM confirmed that its senior leaders did not meet with GSA and USPS. In some cases, headquarters OFAM officials were unaware of ongoing maintenance issues at the IMFs. For example, when we presented photos of the large safety net containing debris at the Newark

Recommendation 2: We recommend that CBP's Office of Facilities and Asset Management evaluate its International Mail Facilities and lease agreements and take actions to ensure safety and the ability to meet screening requirements.

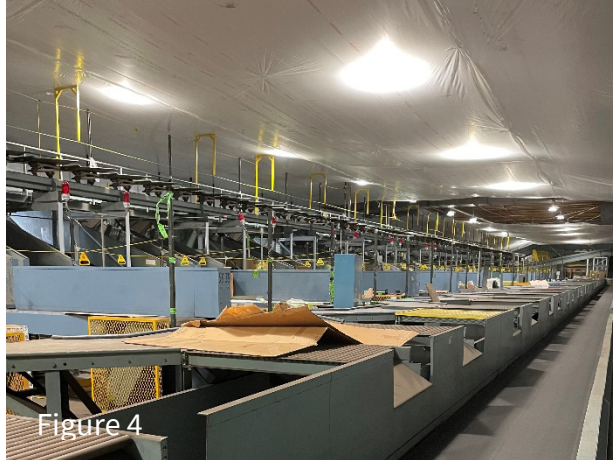
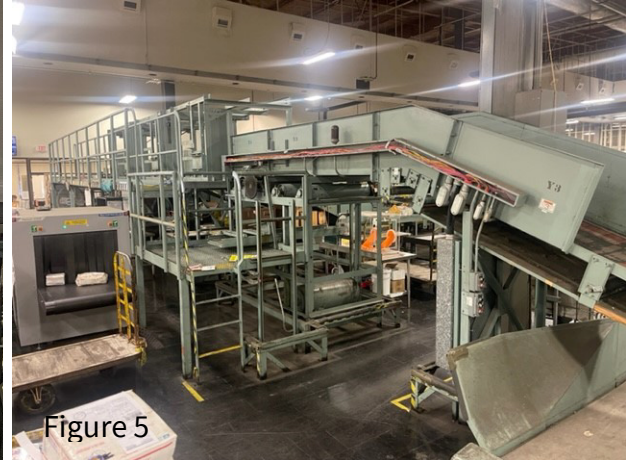
During a visit to the Newark IMF, we observed that 46 percent of CBP's lease space was filled with unused conveyor belts making the space unusable for CBP's operations, such as screening mail. A supervisory CBP officer said CBP has not used the conveyor belts since 2016 due to a change in its operations. We observed layers of dust, rodent droppings and traps, and packages postmarked from 2020 on the belts. Both regional and headquarters OFAM officials were unaware of the unused space at Newark.

At the Honolulu IMF, we observed that 42 percent of the space designated for screening mail was occupied by inoperable conveyor belts. Figures 4 and 5 show sections of unusable space at the Newark and Honolulu IMFs. In 2019, at CBP's request, GSA identified the belts were inoperable and had been since 2013 and requested that USPS remove the belts. Although regional OFAM and GSA officials were aware that USPS would not remove the belts, CBP continued to pay rent for the unused space and renegotiated its space agreements on three occasions after its 2019 letter. See Appendix C for a breakdown of unusable space at the Newark and Honolulu IMFs. See Appendix E for Potential Monetary Benefits.

Figures 4 and 5. Unused and Inoperable Conveyor Belts Occupying Space at the Newark IMF (left) and the Honolulu IMF (right), respectively

These issues occurred because OFAM did not monitor or escalate regional IMF issues. Headquarters OFAM officials stated that they were unaware of the unusable space at the Newark and Honolulu IMFs. Although the unused conveyor belts had resulted in unusable space at the Newark IMF since 2016, regional OFAM contractors reviewed CBP’s footprint with GSA in 2019 during a lease renewal and continued leasing that area. Additionally, a regional OFAM official was aware that Honolulu had broken conveyor belts but did not escalate this issue to headquarters. Although they were onsite or were made aware of issues, regional OFAM officials continued to pay rent for space occupied by unusable and inoperable conveyor belts.

- a. evaluate all International Mail Facility space agreements to identify unusable space for future cost savings; and
- b. revise agreements with unusable space, given the \$3.2 million in funds that could have been put to better use identified in this audit.

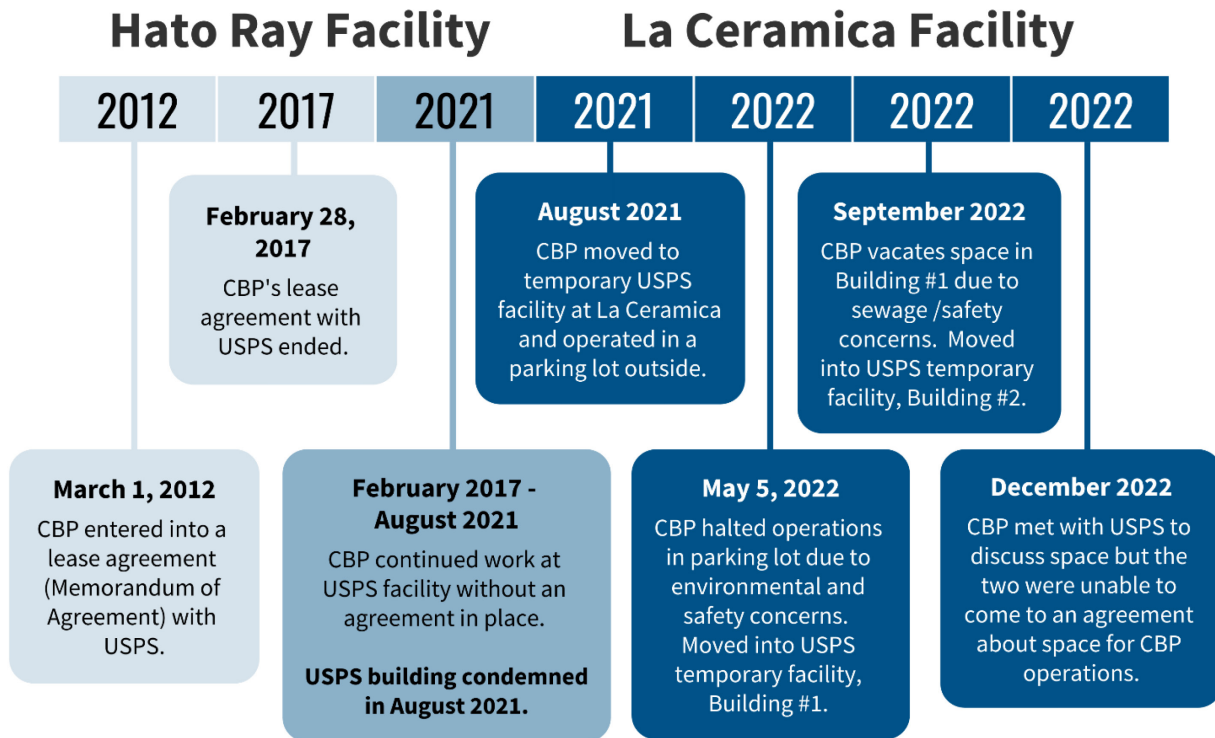
History of CBP's San Juan IMF Operations

for an additional 4 years and 6 months without a renewed space agreement. In August 2021, the Hato Rey facility where the San Juan IMF was located was condemned, and CBP was forced to move its screening operations to the parking lot of a facility known as La Ceramica. Due to environmental and safety concerns, a local San Juan official halted CBP operations in the parking lot in May 2022, and the IMF moved into a building at the La Ceramica facility. Within months, CBP had to vacate that space due to sewage and safety concerns and moved its IMF operations to a different La Ceramica building in September 2022. Appendix D shows a timeline of the San Juan IMF's operations.
